FACILITY ASSESSMENT BOOKLET

CLINTON PUBLIC LIBRARY

OCTOBER 2017

FEH DESIGN

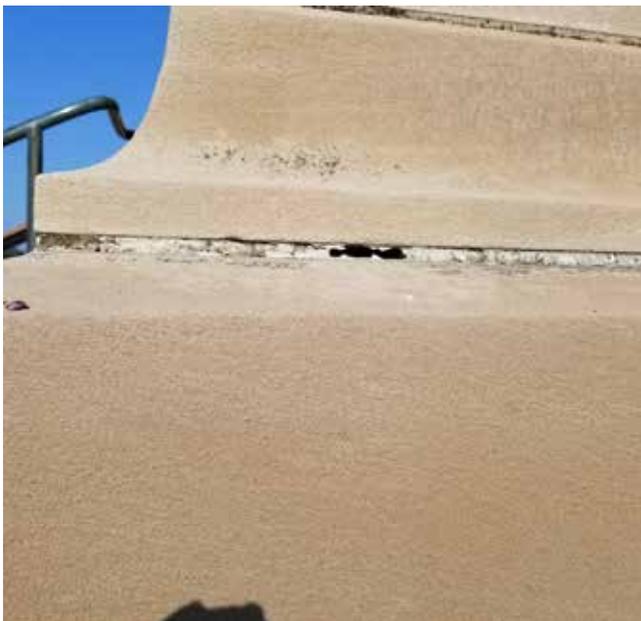
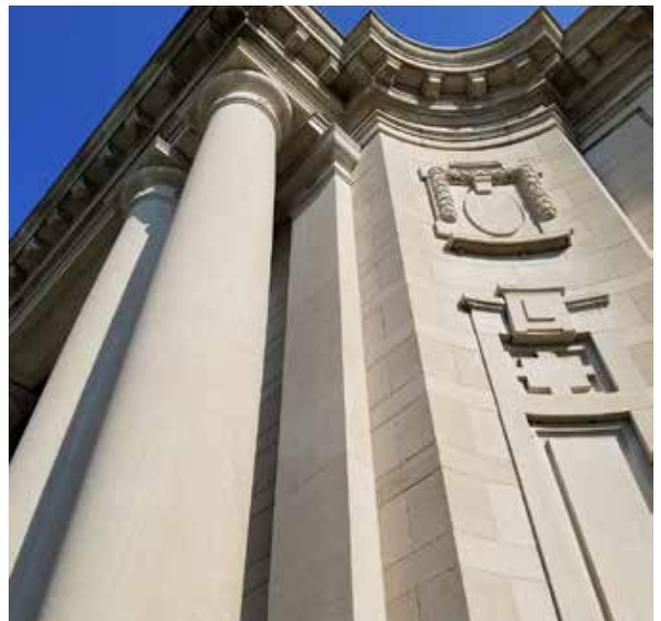
There are multiple locations along the bases of the pedestals and at the tops of the pedestals where the sealant between

stone pieces has degraded and is now exposing the stone to water. It is critical to maintain the sealant due to the destruction that can happen due to water infiltration.

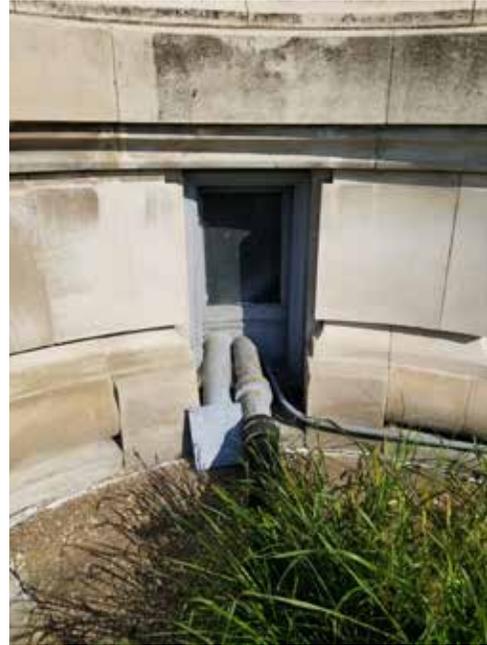
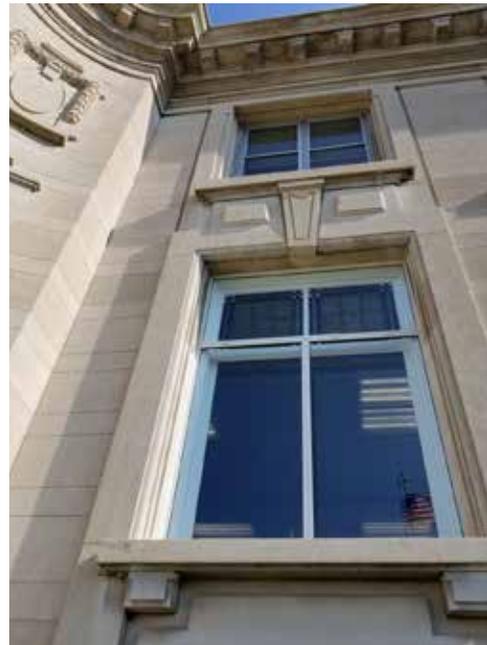
There are also multiple locations where various piping and conduits are run through the exterior of the building. Each penetration through the stone is an opportunity for water to enter the wall and degrade the stone and interior construction.

Sealing the openings around the piping or conduit and maintaining the sealant is critical.
