FACILITY ASSESSMENT BOOKLET

CLINTON PUBLIC LIBRARY

OCTOBER 2017

FEH DESIGN

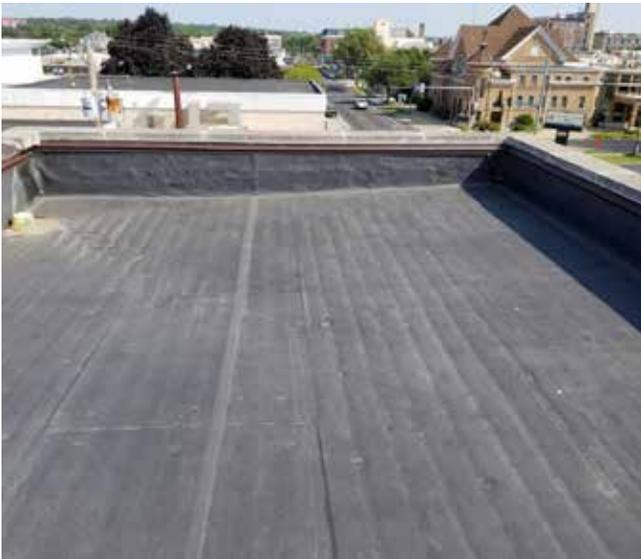
40

The northwest window sill is in bad shape	Rebuild window sill	Urgent	\$800	
	Roof requires some sealant work. The membrane is about 10 years old	Replace sealant where needed	Urgent	\$2,400	40, 43, 44
	Parking lot has many problem areas needing repair	Repair and cut through curb	Required	\$8,000	274, 275, 276
	Exterior surface electrical is exposed near downspout at back	Place wiring in conduit.	Required	\$1,200	26
	Chimneys require tuckpointing	Repair and tuck point	Recommended	\$2,600	64
	Exterior sidewalks are cracked heaved and surface is uneven	Replace	Recommended	\$8,000	35
	Basement windows are generally in poor condition	Replace windows. Provide type that will allow emergency egress if needed	Recommended	\$40,000	
Functionality issues	Shelving stacks are too high for reach, viewing and ADA access	Modify or replace shelving		\$80,000

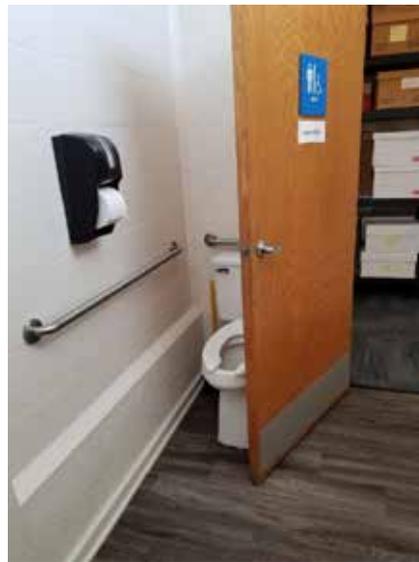
LYONS BRANCH LIBRARY					
Building Area	Code/ Maintenance Item	Recommendation to Correct	Urgency Level	Costs	Photo Reference
Architectural - Interior					
Main Level					
North Entry doors	The door closer is worn out. It closes with full force with no hold	Replace doors	Required	\$8,000	87, 90
Men's restroom	The door jamb on the knob side is too close to the wall. Must be a minimum 12" on the push side and 18" on the pull side	Move the door	Required	\$3,000	80, 81
	The toilet is behind the door and does not allow adequate space as required by ADA	Move toilet	Required	\$5,000	79
Women's restroom	The door jamb on the knob side is too close to the wall. Must be a minimum 12" on the push side and 18" on the pull side	Move the door	Required	\$3,000	78

LYONS BRANCH LIBRARY					
Building Area	Code/ Maintenance Item	Recommendation to Correct	Urgency Level	Costs	Photo Reference
	The toilet is behind the door and does not allow adequate space as required by ADA	Move toilet	Required	\$5,000	78
Staff work area	The staff sink is not ADA compliant	Swap out sink base for a ADA compliant lavatory	Required	\$2,000	69
Exterior					
North Entry	The north entry has a step, more than half of entries need to be ADA compliant. This needs to be corrected	Replace with continuous or extend handrails	Required	\$5,000	90
North west planter wall	Stone of wall is broken loose	Repair stone wall	Recommended	\$500	89
South entrance ramp	Handrails are not compliant	Modify rails to comply with ADA requirements	Required	\$2,200	83, 84
South parking lot	The light level is low at night, security is an issue	Provide additional exterior lighting and video camera	Recommended	\$3,000

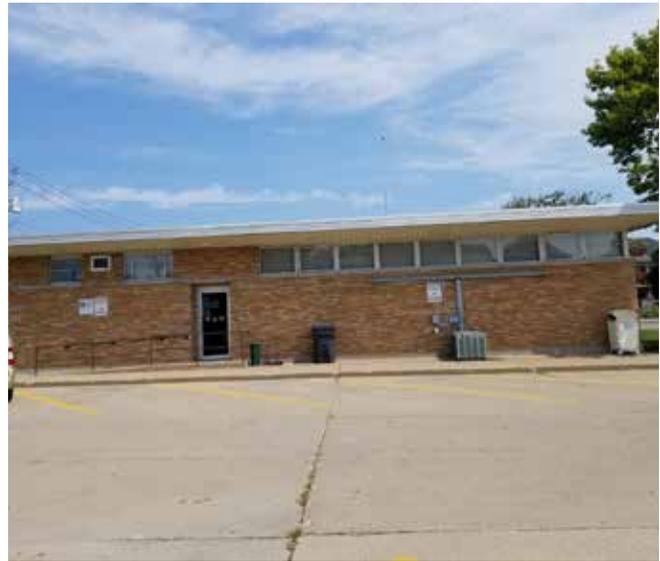
Windows	The windows are worn out and not energy efficient	Replace 30 windows	Recommended	\$25,000	83, 84, 85, 86, 87
Roof	The membrane roof has been resealed	Replace roof in five years	Recommended	\$20,000	
Parking	The handicap parking is not ADA compliant	Modify as needed	Required	\$2,500	83
Total cost expectation at Lyons				\$84,200

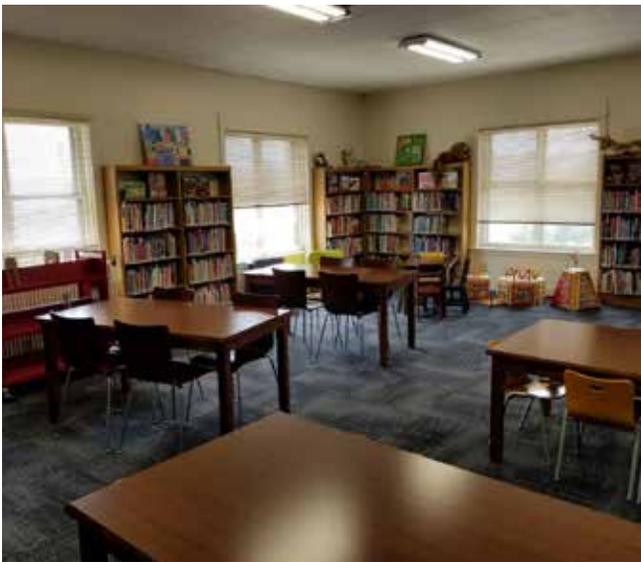
204

Radiators	They have hand controls with no nighttime setbacks	Upgrade controls	Recommended	\$10,000	204, 205
	Radiators get very hot	Replace or provide covers	Recommended	\$12,000	
Window replacements	Windows are inefficient	Replace storm windows on upper floor	Recommended	\$40,000	10, 11, 12
Above ceiling air handling unit	Beyond its useful life and inefficient	Replace	Recommended	\$16,000	
First floor air handling unit	This is an older unit, fan and bearing have been replaced a few years ago	Replace unit	Recommended	\$20,000

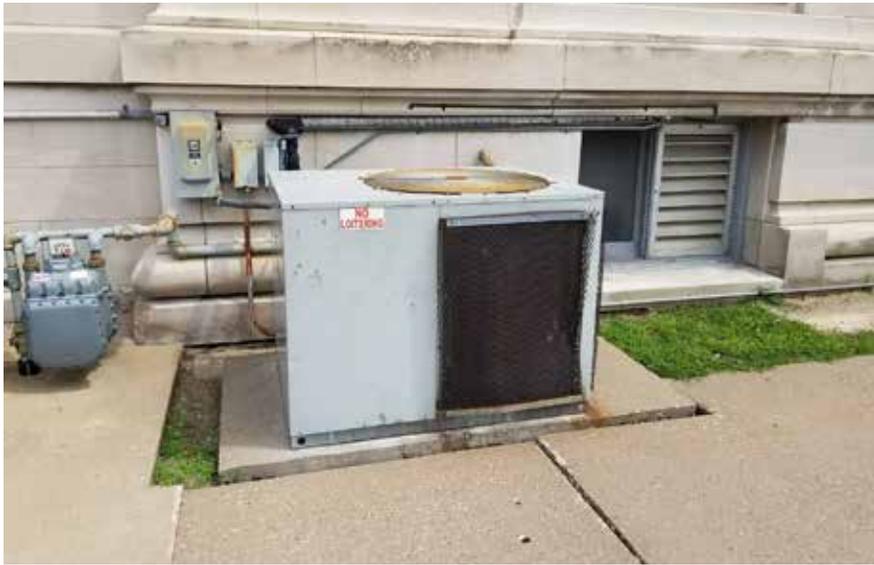
230

Architectural Exterior					
Exterior	Front stone stairs are settling	Repair with new foundations	Urgent	\$32,000	4, 5, 257, 258, 260
	Basement hatch wall and lid is deteriorated	Replace	Urgent	\$10,000	230, 232
	At grade condensing unit is beyond its useful life. Conduit is corroded	Replacement of unit is noted above, replace conduit	Urgent	\$800	231
	Several locations where storm window gaskets have shrunk and are coming out.	Replace gaskets	Urgent	\$2,400	233, 234
	The rear entrance and stair enclosure is not ADA compliant and is not in keeping with the historic Library building	Remove and replace	Recommended	\$65,000	236
	Some electrical conduit is missing covers.	Replace wiring and provide cover	Urgent	\$1,200	239
	The west walk way has some heaved walk surface	Remove and replace with level concrete surface	Urgent	\$800	240, 241

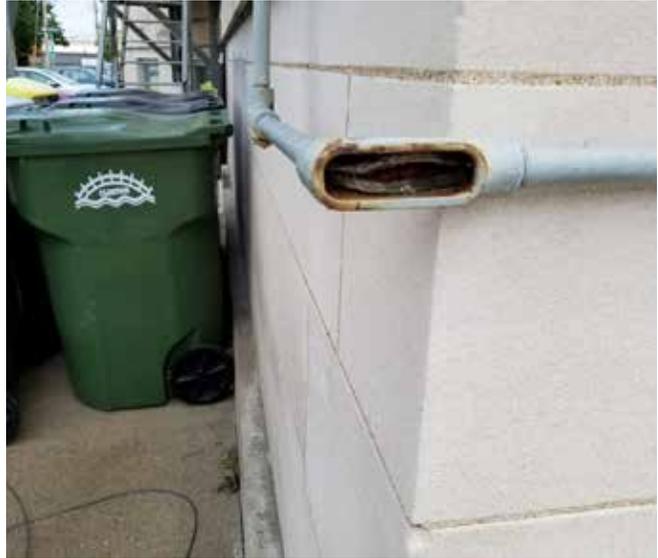
MAIN LIBRARY					
Building Area	Code/ Maintenance Item	Recommendation to Correct	Urgency Level	Costs	Photo Reference
	Wood window frame at louver has peeling paint and deteriorated wood	Remove paint, repair wood, repaint	Recommended	\$800	242
	Electrical conduit at grade near the above window id=s corroded and missing sections	Replace	Urgent	\$800	242
	Wood detailing under windows is deteriorated	Repair and repaint	Recommended	\$5,000	243, 244
	Stone is spalling and some of the face is gone	Apply breathable crystalline sealer	Recommended	\$4,000	245
	Some of the mortar is missing from the stone joints.	Provide spot tuckpointing, stone repair sealer	Urgent	\$250,000	246, 247, 248, 249
	Wood windows need repair	Repair about 30 windows	Recommended	\$25,000	15, 16, 17, 18, 19
	At grade paving against the building is old and allows water infiltration	Seal up sill	Recommended	\$1,600	238
	Pigeons like the main entrance area	Install deterrent	Recommended	\$1,200
